NIPPON KAIJI KYOKAI

CERTIFICATE

No. FE13RT00085

ONE (1) PIECE OF A-FRAME (RECONDITIONED)

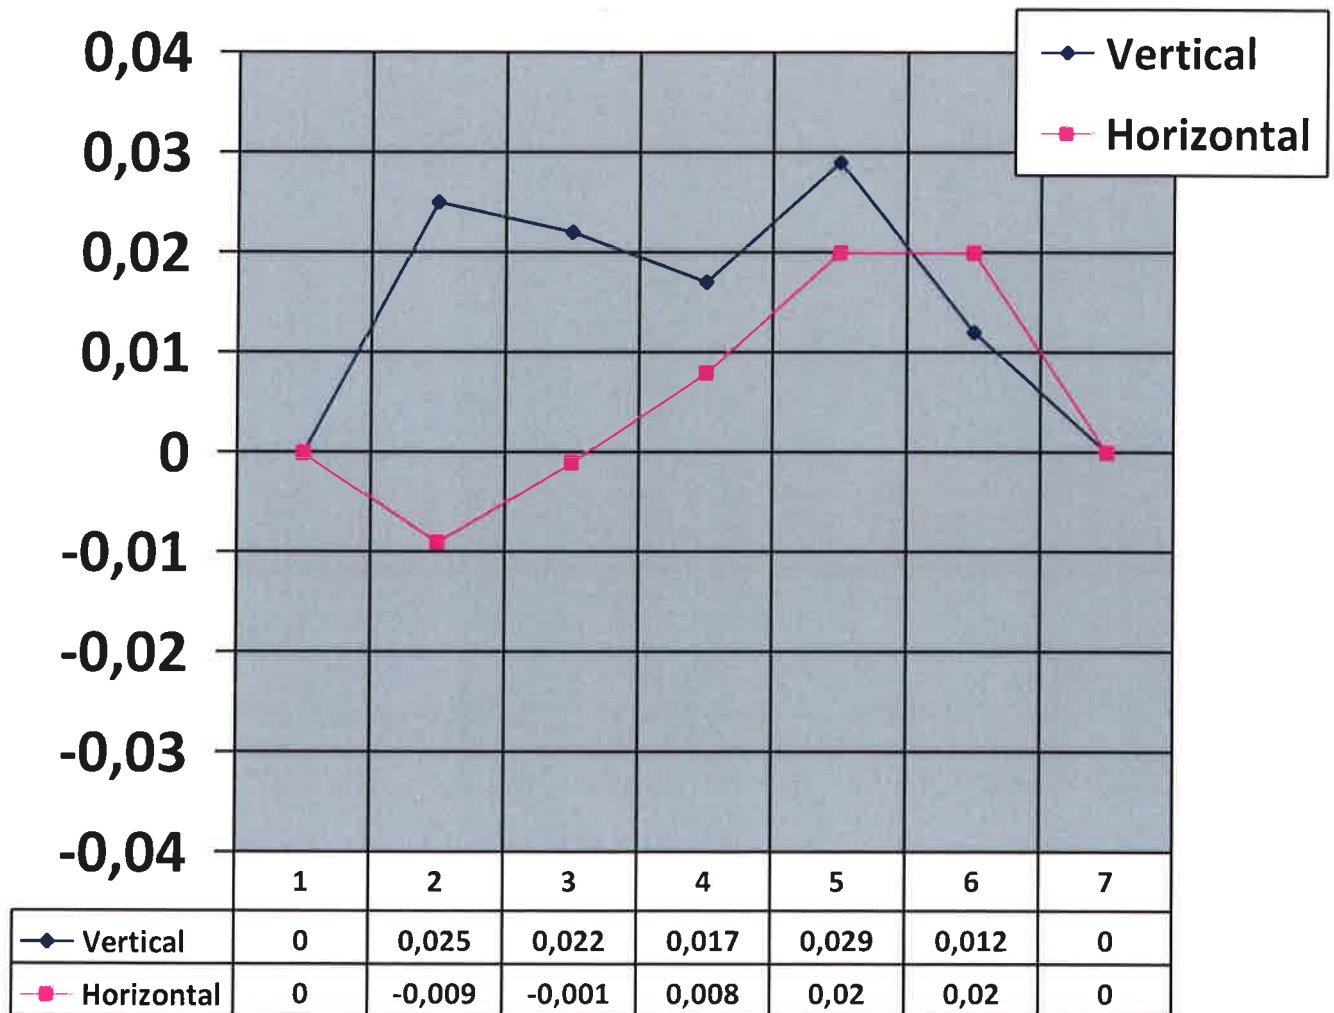
Bedplate alignment

Distance	0	510	510	510	510	510	510
----------	---	-----	-----	-----	-----	-----	-----

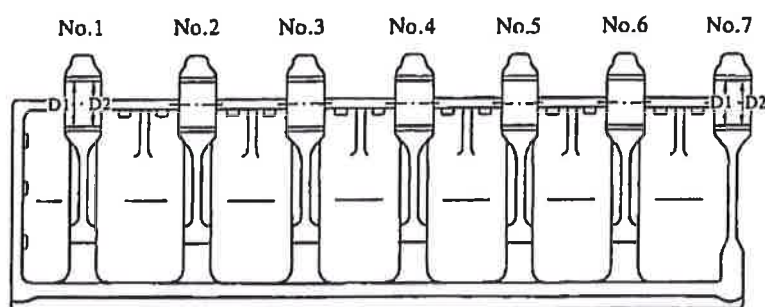
Main journal pockets

Position	1-1	1-2	2-1	2-2	3-1	3-2	4-1	4-2
A-A	+5	+5	+5	+5	+5	+3	+5	+5
B-B	+3	+2	+4	+3	+4	+4	+3	+3
C-C	+4	+4	+6	+6	+2	+3	+5	+6

Position	5-1	5-2	6-1	6-2	7-1	7-2
A-A	+5	+5	+6	+5	+5	+5
B-B	+4	+4	+3	+3	+4	+3
C-C	+6	+4	+5	+3	+5	+6
